# Manhole Inspection Summary

## Manhole # S13OO1008MH

Insp Date: **11/29/06 10:26 AM**

**Location** Address: **4802 POE AVBE**

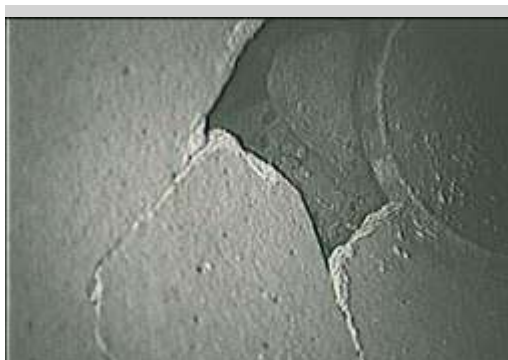
Inside of the I5

Comments **The I5 pipe is broken inside. The O12 pipe picture shows Channel deterioration.**

Broken pipe.

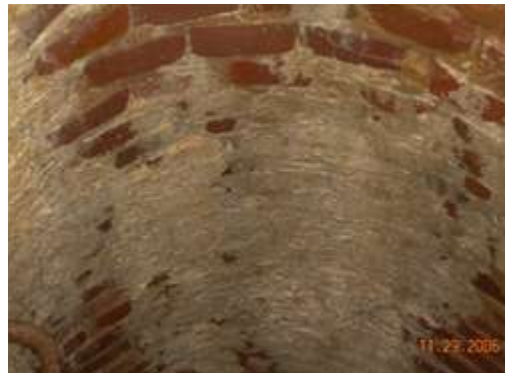
Defect

Infiltration: ☐ None ☒ **Joint** ☐ Cracks ☒ **Mortar** ☐ Roots ☐ Wall

Infiltration: ☐ None ☐ Joint ☐ Cracks ☐ Mortar ☐ Roots ☒ **Wall**

Adjustment and Corbel infiltration.

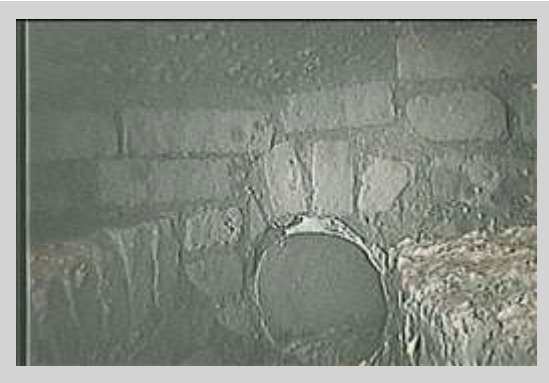
### 8 in. Circular Gravity Sewer Pipe Out @ 12 O'Clock

Infiltration: **Evidence** Pipe Seal Cond: **Unknown**

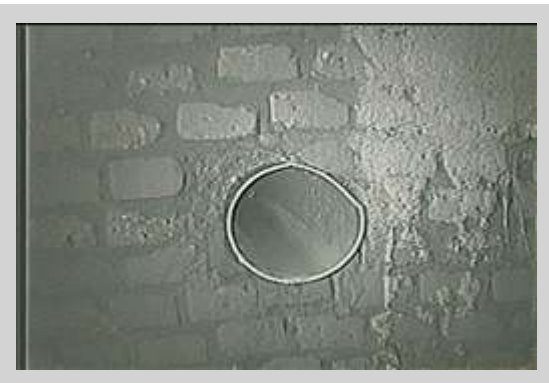
### 8 in. Circular Gravity Sewer Pipe In @ 2 O'Clock

Infiltration: **None** Pipe Seal Cond: **Cracked**

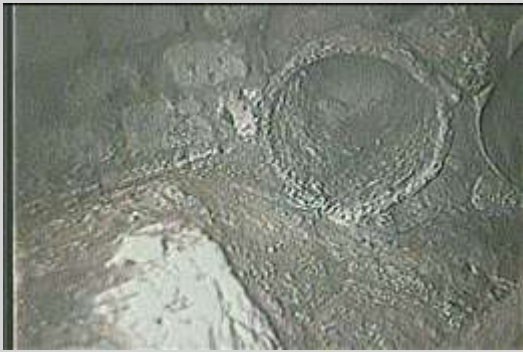
Pipe In @ 4 O'Clock

Infiltration: **Evidence** Pipe Seal Cond: **Unknown**

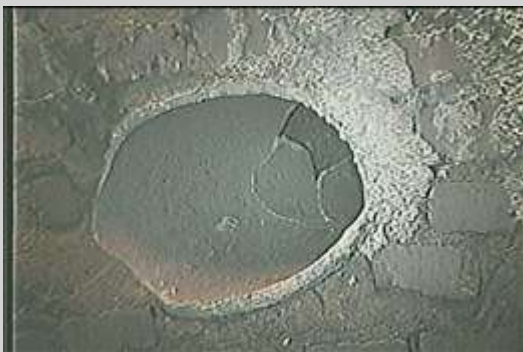
Pipe In @ 5 O'Clock

Infiltration: **Evidence** Pipe Seal Cond: **Cracked**

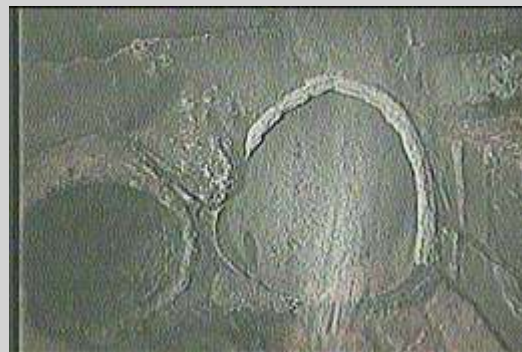
Drop In @ 5 O'Clock

Drop: **Outside** Rod and Bar  
Angled: **Yes** Reading: **10.48** (ft.)  
Inv Depth: **11.48** (ft.)

Drop Condition: **Open**
